BELLE CREEK WATERSHED DISTRICT

TO: Belle Creek Watershed Board
RE: Inspection Tour

December 12, 2013

MAINTENANCE INSPECTION SHEET
FLOODWATER RETARDING & MULTIPLE-PURPOSE STRUCTURES
Multiple Structures

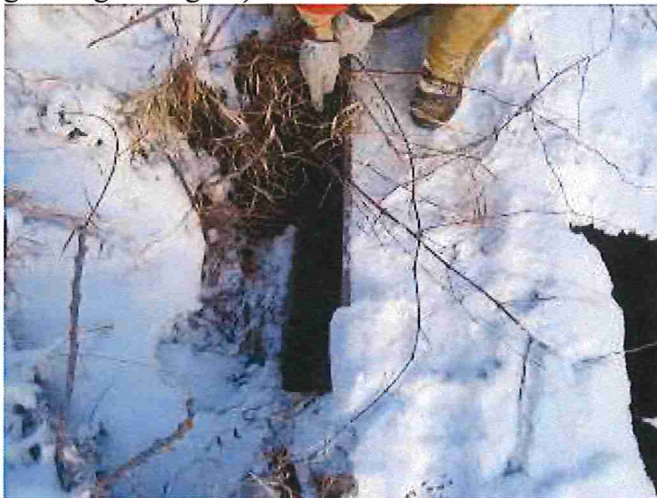
Critical Items: a void has formed behind the impact basin headwall. This should be investigated to find the cause and filled in.

void behind headwall, approx. 2-3' deep.

- Spillway - needs mowing in 2014 to control small brush
- UPS -debris removal and burn.
- DS - mow sumac around outlet.
 - Excavate behind splash basin and fill subsidence in 2014. Use excavator to remove and replace safety guard.

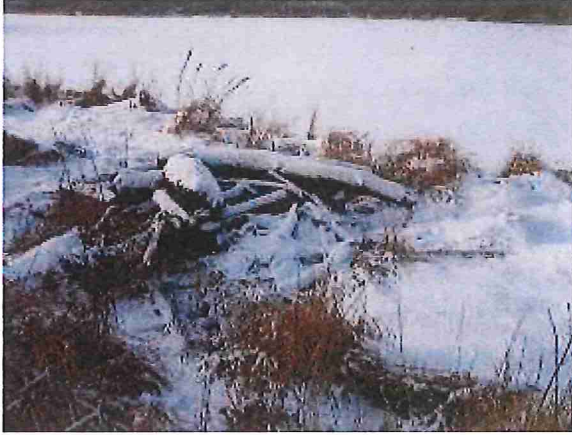
Debris catching on the inlet continues to be an issue and should be monitored and regularly cleaned off.

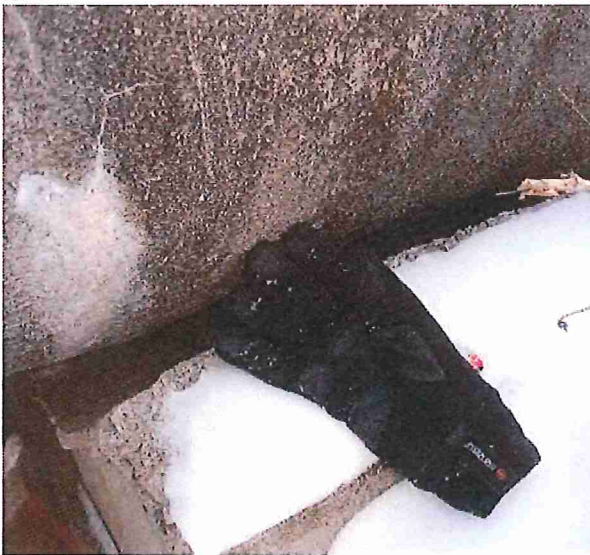
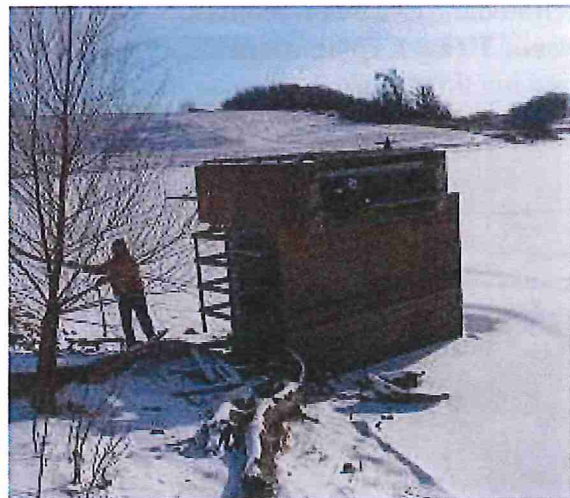
R-9

Minor Items: tree near inlet

Critical Items: The support pad under the outlet pipe has settled; grout should be used to fill the void.

- UPS -minor debris cleaning needed at inlet.
- DS - gap between pipe and support column. needs to be addressed in 2014.
